The Journal of the Roof Consultants Institute

January 2005 • Vol. XXIII • No. 1 • \$10.00

# The House Roof Story

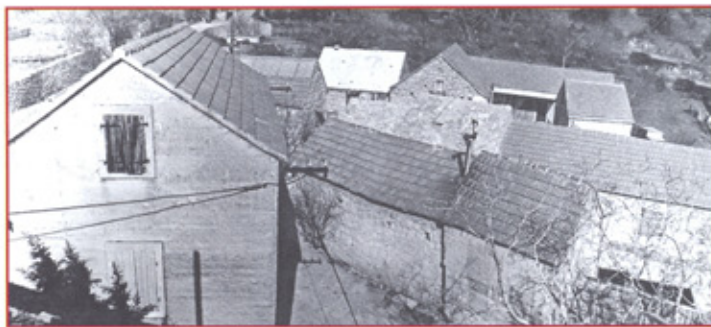
roofs sport a predominance of red clay tile roofs.) In other towns, stone tiles have been gradually replaced with red tiles so that these days the image of traditional authentic architecture is light grey stone walls and red tile roofs offset by green shutters (Figures 1a and 1b).

**Figure 1: Neighboring stone and clay tile roofs common to the area.**

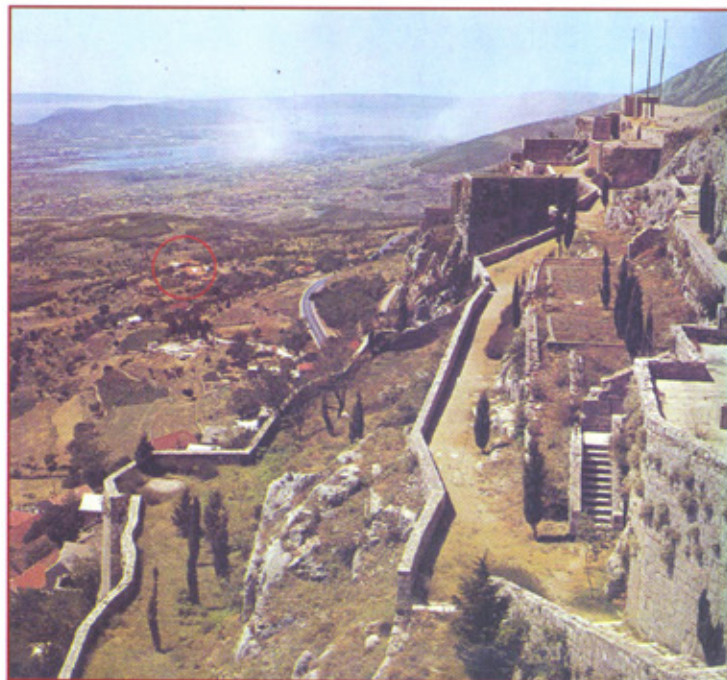
**Figure 3:** Current view from the Klis fortress to the city of Split. The circled area is the author's home.

305 AD (see Fig. 2). Nearby, on the pass between the mountains of Mosor and Kozjak, 4km from the sea and 180m above sea level, on the 43.5° north parallel, is the town of Klis. It is there that my house is located, eight miles by air from Diocletian's palace (see Fig. 3). The climate here is mild enough to grow fig and olive trees, and harsh enough to demand a proper wood supply for the winter

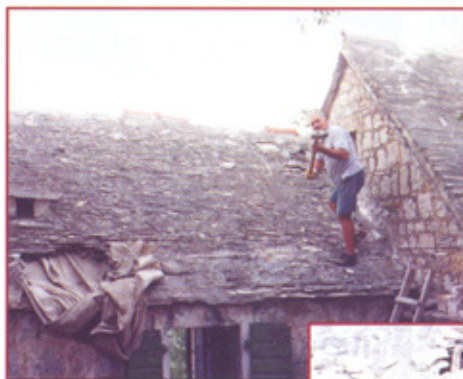
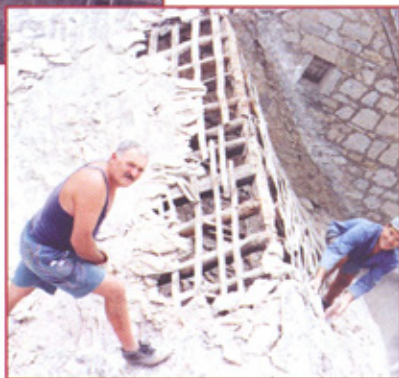
Wooden split laths were removed (see Figures 6a - 7b). A few rafters were torn; others had lost their shape but could be reused. New 5x8cm rafters were laid and connected with the old ones. New eaves were made of existing stones and fixed with concrete to both old and new rafters. 3x5cm-laths were placed for tile sub-layers, tiles were set, and the connections between the roof and neighboring walls were mortared.

**Figures 6a and 6b: Beginning of work; taking stone tiles down from the roof.**

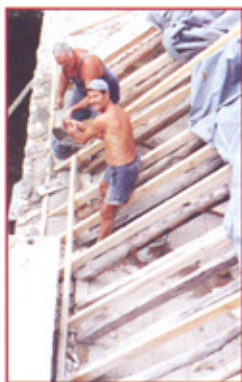
**Figures 7a and 7b: New rafters added to the old; new eave reinforced by concrete.**

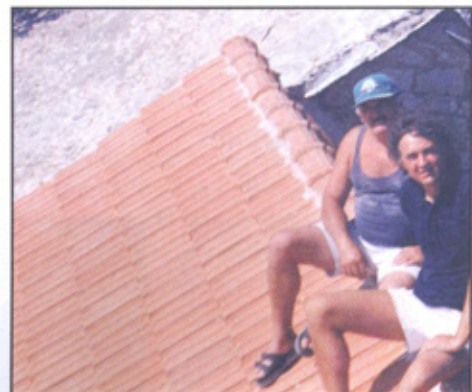
After repairs were completed, heavy autumn rains came, and unexpected problems occurred. The beautiful roof did not resist leakage, and water dripped through. Leaks became my obsession in the following

years. The roof had a really fine slope – almost 45° – and tiles had been laid very neatly (Figure 8) but...

**Figures 8: The roof is finished, but....!**

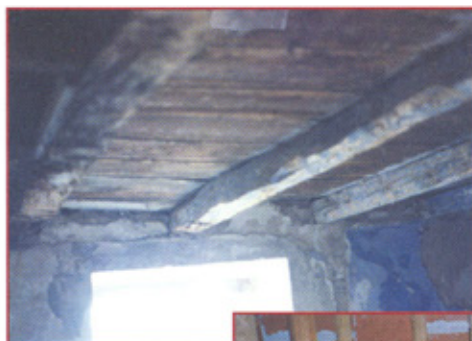
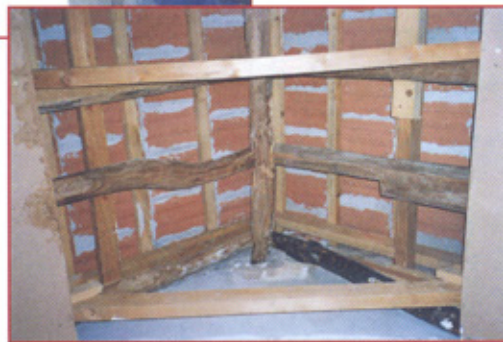
I then concluded, after the joints were filled with cement glue and mortar, that the problem was the porosity of some tiles. I thought that spreading the silicon liquid over the tile would stop water from pouring in. It was done, but without any effect (Figures 10a and 10b). All of these "healing" attempts increased the costs by another 500€.

**Figures 10a and 10b: Corrective attempts from inside; attic boards and joists were later removed.**

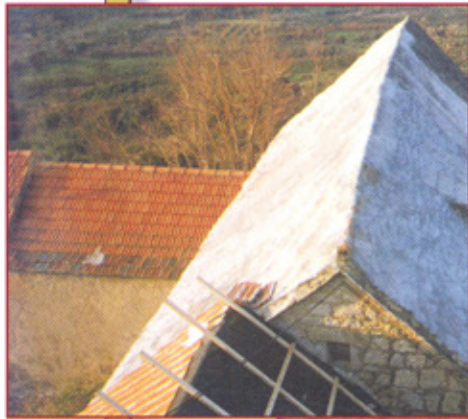
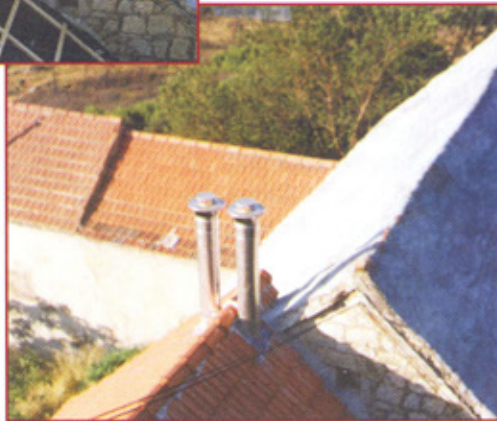
**Figure 13a: Bitumen sheeting with laths.**  
**Figure 13b: Later penetration of two chimney tubes (protected with 2 mm lead sheet).**  
 So far, it works perfectly.

The problem of how to fix new laths for the existing roof was solved with 20cm length nails. Holes were drilled on the positions of the rafters underneath, and nails were easily inserted (Figures 13a and 13b). Two workers completed this job in four days in February 2001 – almost three and a half years after repair had first begun. Luckily, I did not need this space badly, so I could

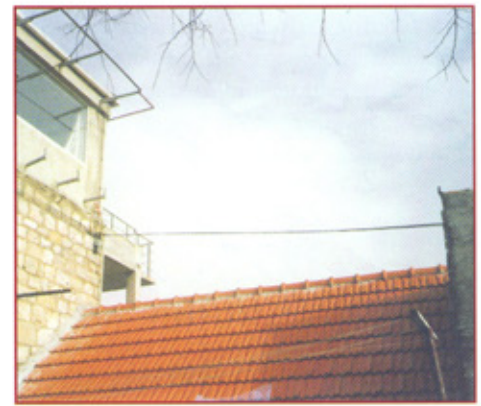
**Figure 14: The roof repair is finally done properly.**

The final decision was to put new brick tiles over the existing roof.
